Manhole Inspection Summary

Manhole # **S13CC_006MH**

Insp Date: **1/21/09 1:45 PM**

Location Address: **2926 ELLICOTT DWY**

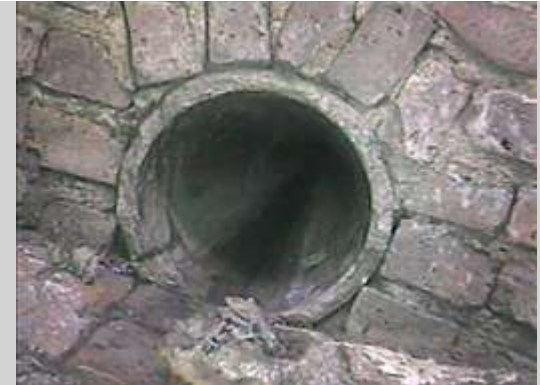
12 O'Clock Outflow

8 in. Circular Gravity Sewer
Pipe Out @ 12 O'Clock

Pipe Material: **Clay** ☐ Pipe Lined

Invert Depth: **3.34** (ft.) Flow Characteristics: **None**

Infiltration: **None** Pipe Seal Cond: **Broken**

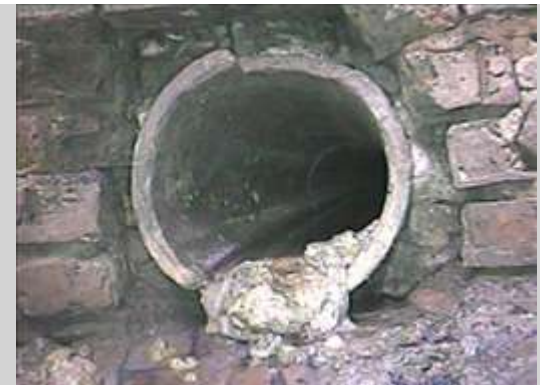
6 O'Clock Inflow

8 in. Circular Gravity Sewer
Pipe In @ 6 O'Clock

Pipe Material: **Clay** ☐ Pipe Lined

Invert Depth: **3.22** (ft.) Flow Characteristics: **None**

Infiltration: **None** Pipe Seal Cond: **Cracked**

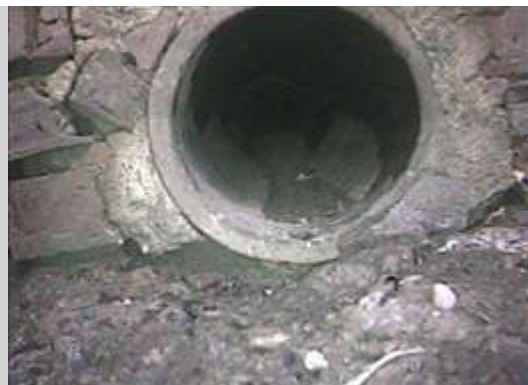
7 O'Clock Inflow

6 in. Circular Gravity Sewer
Pipe In @ 7 O'Clock

Pipe Material: **Clay** ☐ Pipe Lined

Invert Depth: **3.16** (ft.) Flow Characteristics: **None**

Pipe Seal Cond: **Cracked**

Connects To: **House connection / Service line**
